DE LOREAN MOTOR COMPANY

SERVICE BULLETIN

NUMBER SC-03-1/82

SUBJECT: SAFETY RECALL NOTICE SUPPLEMENT
SAFETY CAMPAIGN # RA-0001 (RECALL)
BALL JOINTS - STABILIZER BAR MOUNTINGS
V.I.N. 560 - V.I.N. 7199

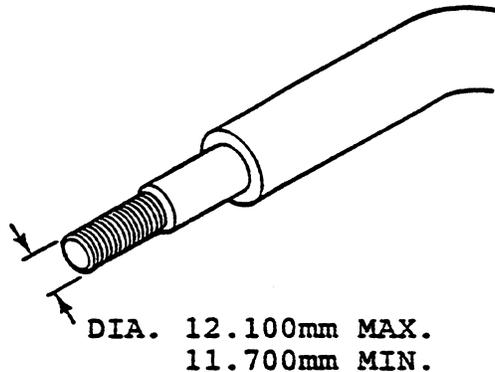
FIGURE 1

11. With a micrometer, measure the outside diameter of the threaded end studs on the stabilizer bar (Figure 1). Reading must be 12.1 mm (.476 inch) maximum to 11.7 mm (.460 inch) minimum.

NOTE: If the reading is below 11.7 mm (.460 inch) replace the stabilizer bar with new unit (P/N 100233).
